East Kent Hospitals NHS Trust Therma Camera

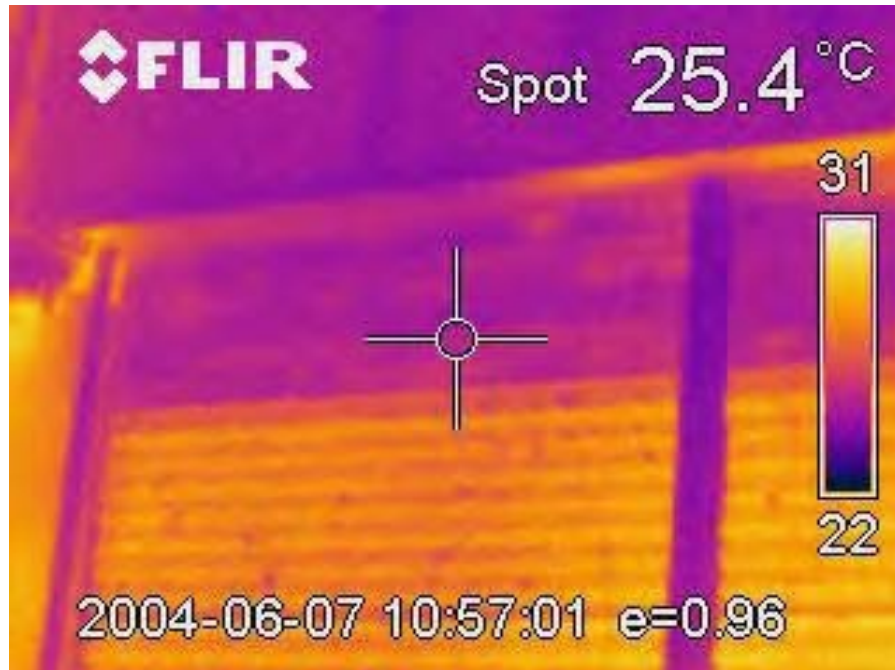
Picture one: Cooling battery on steam chiller. The difference in the orange to purple shows that the water is not flowing correctly and not working efficiently.

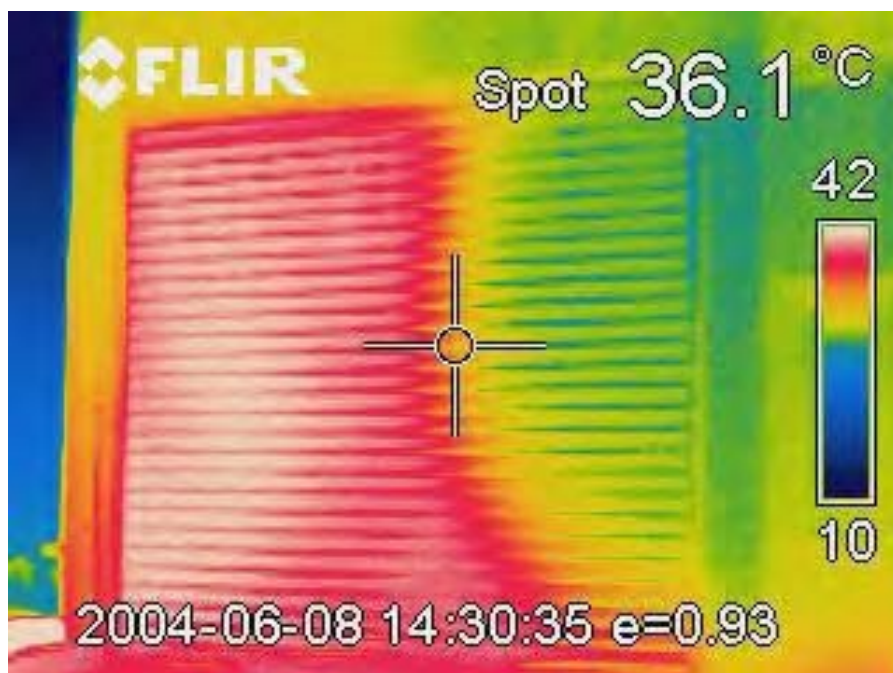
Picture two: Water towers. The picture showed the estates staff that hot air was being drawn back in and using hot air instead of cool air to cool the battery. This was a 25 year fault, which has been easily resolved and improved efficiency.

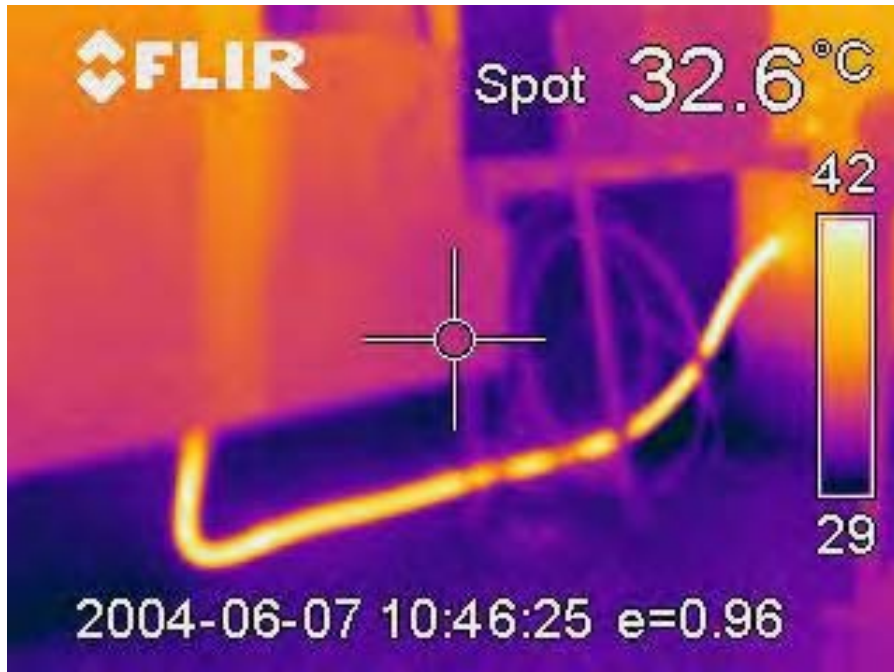
Picture three: A cable leading to a control panel. The colour of the cable shows that it is overheating. As the cable is leading to a control panel in a plant room, it is important that it does work correctly and does not give off heat.

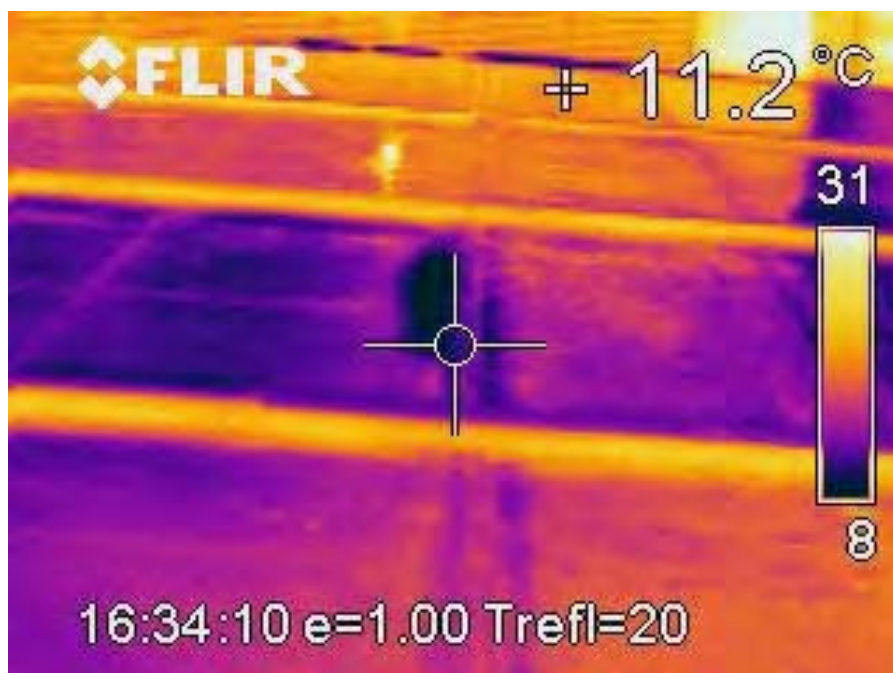
Picture four: Flat roof. The area that is very dark purple/black is where water was entering the roof. The area of dark purple to the left is where the water was between the layers of felt.

The pale purples grid lines are the joists and show heat transfer.
