The impact of image resolution

Comparing how the image result changes when using different camera detector resolutions.

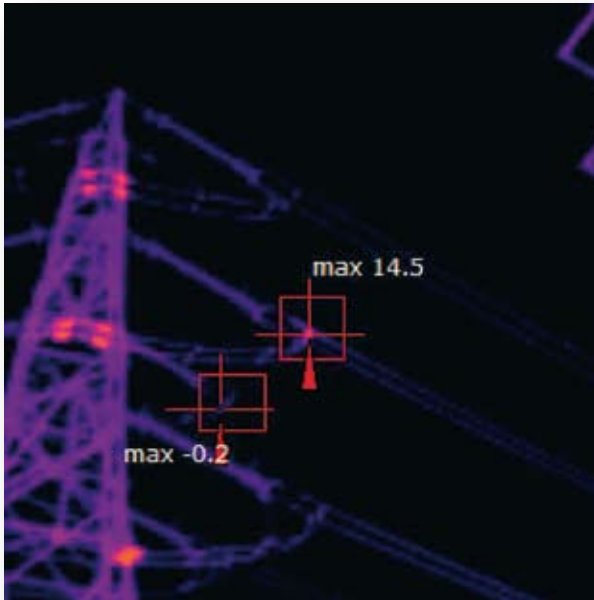
Image of a hot spot on a power line in a utility substation.
(Distance approx 20 m)

Image taken with 120x120 pixel resolution and <100mK thermal sensitivity.

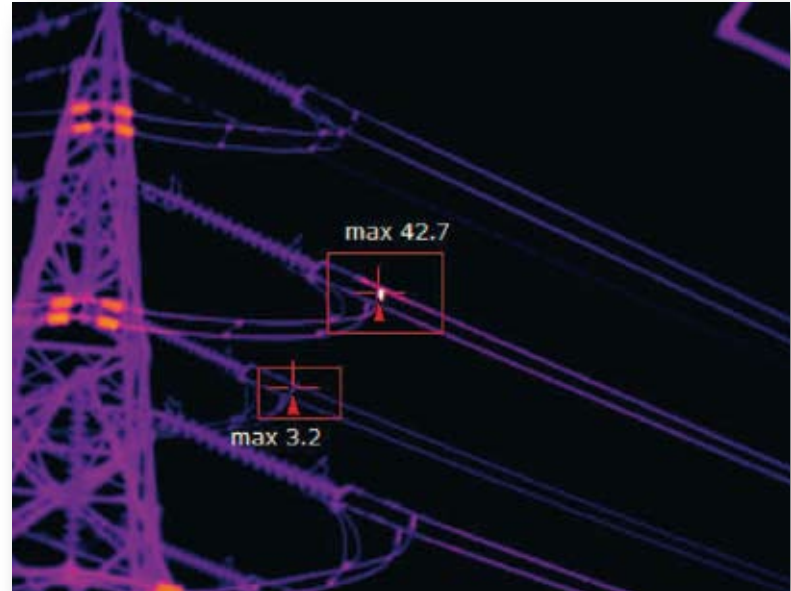
Image taken with 320x240 pixel resolution and 50mK thermal sensitivity. Please note how the increased number of pixels will result in a more accurate temperature reading in the hot spot.

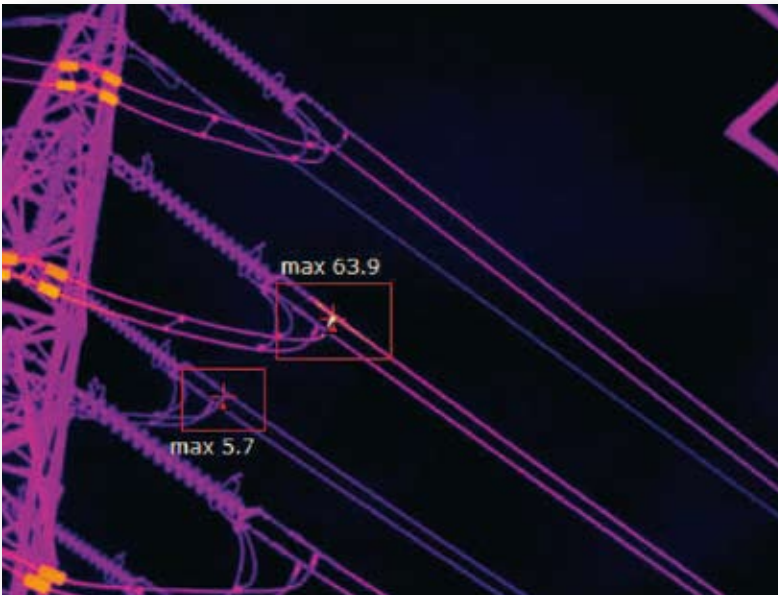
Image taken with 640x480 pixel resolution and <45mK thermal sensitivity. Notice how the hot spot now is clearly visible and that the increased number of pixels will result in an even more accurate temperature reading in the hot spot. It is now clear that there is a problem in the power line.

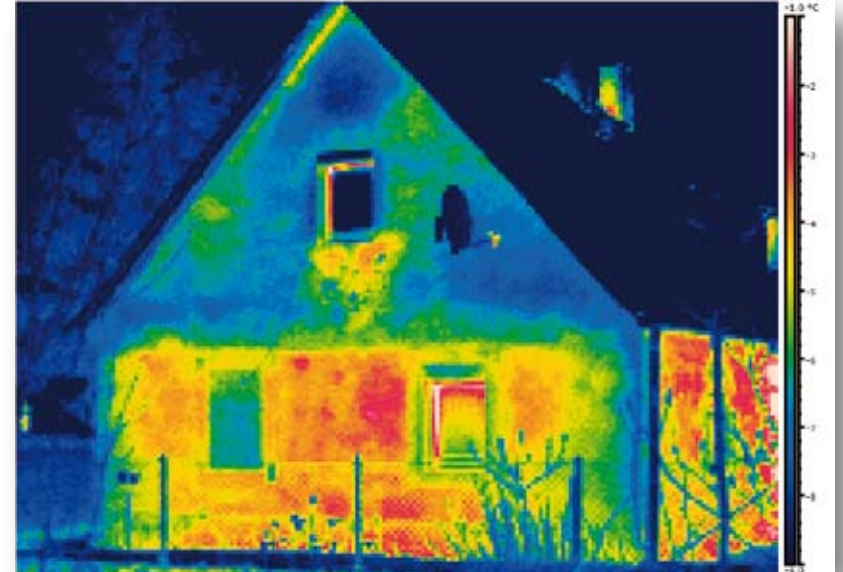
Image taken with 200x150 pixel resolution and <70mK thermal sensitivity.

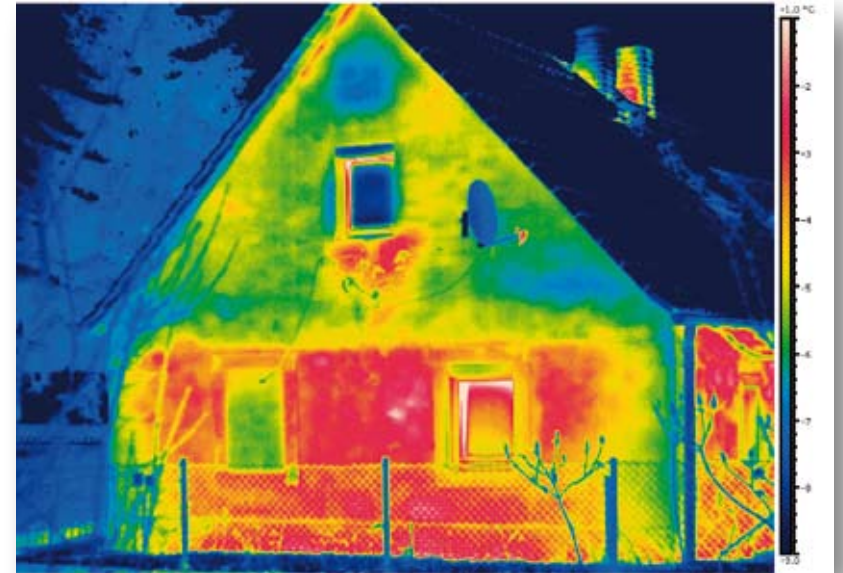
Image taken with 640x480 pixel resolution and <45mK thermal sensitivity. The increased number of pixels will result in a much clearer picture where small details are very visible.

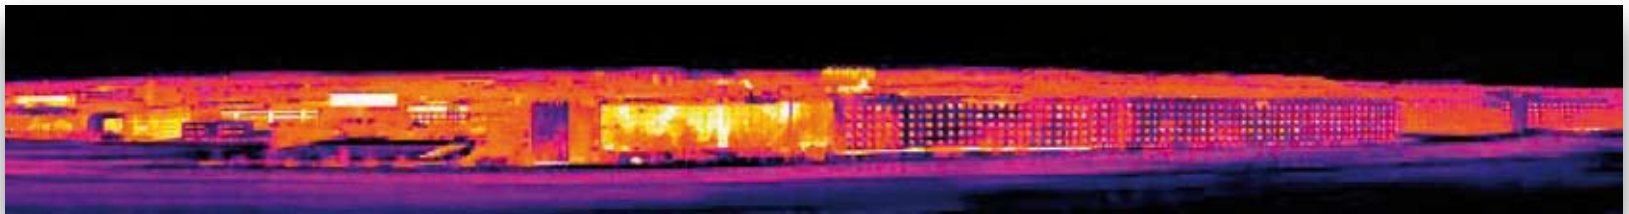
Panorama image taken with 200x150 pixel resolution and <70mK thermal sensitivity.

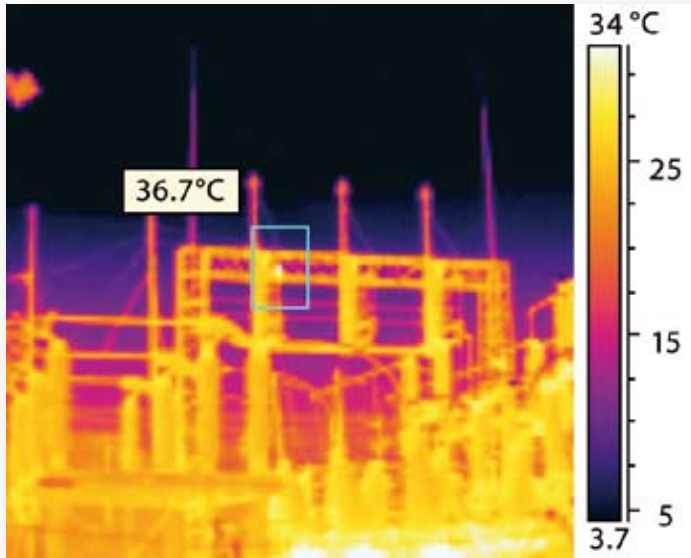
Image taken with 120x120 pixel resolution.
